**Flood Control Project Maintenance
Levee Inspections**

Fall 2016 Levee Maintenance Deficiency Summary Report

Sacramento River Basin

Sacramento Maintenance Yard Putah Creek

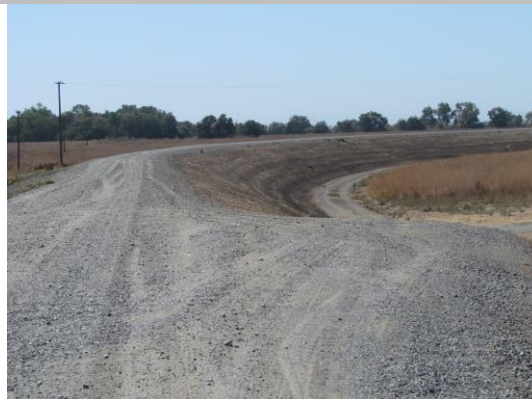
Photo 1 of 1 : FA_2016_ST0007_282_20_20161102_00024.jpg

Putah Creek Unit 1 levee mile 0.00 landside slope.

LM Start	0.00	Rating **	A	Issue No.	21
LM End	8.70	Issue Type +	Ma	Location *	WS
Category	Earthen Levee			GPS Latitude/Longitude	
				Start	End
Item	Vegetation			38.523623 °	38.523945 °
				-121.631427 °	-121.783301 °
DWR ID	DWR_ST0007_01_f_2016_21				
Comment Code					
V1 : Control annual grass and weeds on the levee slopes and easements.					
Inspector Comment

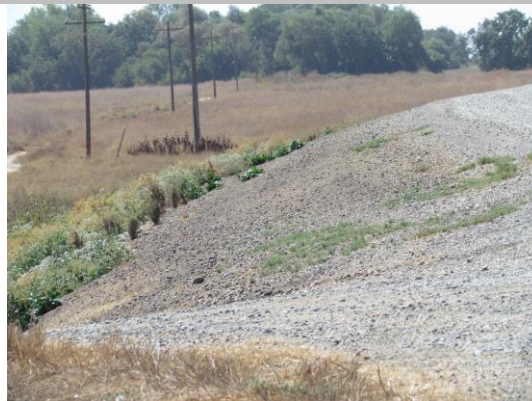
Photo 1 of 1 : FA_2016_ST0007_282_21_20161102_00025.jpg

Putah Creek Unit 1 levee mile 0.00 waterside slope.

LM Start	0.04	Rating **	M	Issue No.	2
LM End	0.12	Issue Type +	Ma	Location *	WS
Category	Supplemental			GPS Latitude/Longitude	
				Start	End
Item	2015 USACE Erosion Survey, DRAFT			38.523119 °	38.521968 °
				-121.631356 °	-121.631519 °
DWR ID	DWR_ST0007_01_f_2016_2				
Comment Code					
Inspector Comment					
2011 - Old cobble site is unraveling, likely causing the toe of the bank to become unstable. 2015: Site is part of the extended inventory, last inspected 2011. [2015 Site ID: PUC_0-1_L]

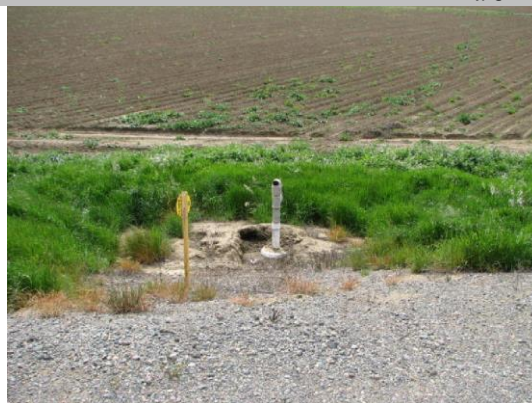
Photo 1 of 2 : UCIP_FA_2016_48122_60481.jpg

Comment Code					
Inspector Comment					
FS_ID:48122 DS_ID:489 EP_NO: 10262 Repair Type: Non-Urgent Crossing Status: Found UCIP Comments: Pump is disconnected from pipe and could cause backflow at highwater event. Can't see size of pipe sleeved through 24-inch pipe. FIELD_STRUCT_DESC: 24-inch steel pipe through levee 12.5 feet below crown with concrete headwalls at both ends. A 18-inch pipe (field verified not 16-inch) is sleeved through the 24-inch pipe with annular space sealed at both ends. This structure was retained under an automatic board order (ABO) issued as Permit No. 10262. (Permit No. 10262 - Wells Fargo Bank, Trustee for S.H.) PVC Sleeved December of 2007 (unknown source). [Additional Reference(s): DWR Levee Log, March 2007. USACE Sacramento O&M Manual 119, December 1952] FS Date: 4/10/2014 2:48:00 PM

WS vent

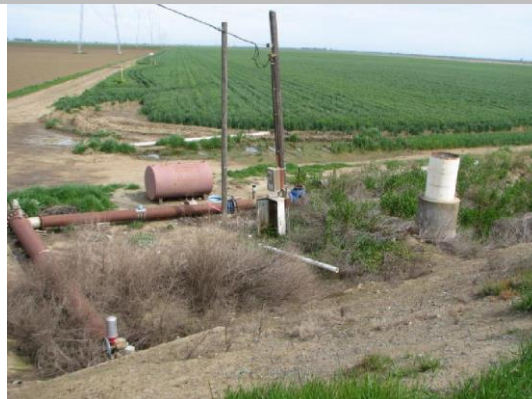
Photo 2 of 2 : UCIP_FA_2016_48122_60483.jpg

Comment Code						
Inspector Comment						
FS_ID:48122 DS_ID:489 EP_NO: 10262 Repair Type: Non-Urgent Crossing Status: Found UCIP Comments: Pump is disconnected from pipe and could cause backflow at highwater event. Can't see size of pipe sleeved through 24-inch pipe. FIELD_STRUCT_DESC: 24-inch steel pipe through levee 12.5 feet below crown with concrete headwalls at both ends. A 18-inch pipe (field verified not 16-inch) is sleeved through the 24-inch pipe with annular space sealed at both ends. This structure was retained under an automatic board order (ABO) issued as Permit No. 10262. (Permit No. 10262 - Wells Fargo Bank, Trustee for S.H.) PVC Sleeved December of 2007 (unknown source). [Additional Reference(s): DWR Levee Log, March 2007. USACE Sacramento O&M Manual 119, December 1952] FS Date: 4/10/2014 2:48:00 PM

pipe and pump/appurtenances on LS

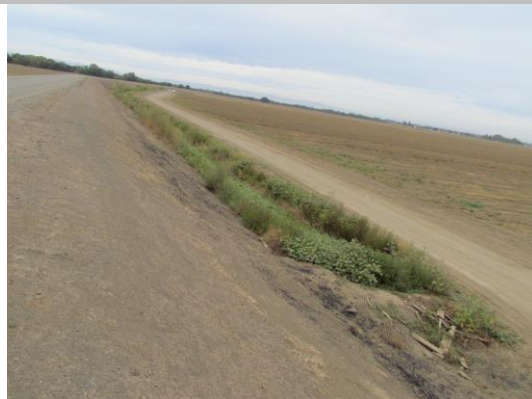
Photo 1 of 1 : FA_2016_ST0007_282_10_20160915_00003.jpg

LM Start	1.48	Rating **	M	Issue No.	10
LM End	2.67	Issue Type +	En	Location *	LS
Category	Earthen Levee			GPS Latitude/Longitude	
				Start	End
Item	Encroachments			38.515322 °	38.517376 °
				-121.654387 °	-121.676054 °
DWR ID	DWR_ST0007_01_s_2012_10				
Comment Code					
DT : Ditch					
Inspector Comment					
This agriculture ditch is owned by Dos Rios Farms. Ending at levee mile 2.72 landside.

Agriculture ditch within 10-foot of levee toe.

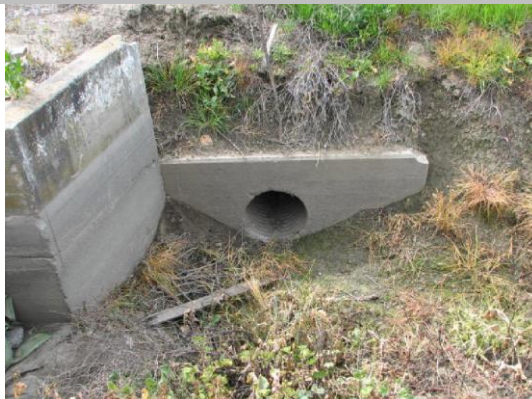
Photo 1 of 2 : UCIP_FA_2016_43033_60465.jpg

FS_ID:43033
 DS_ID:491
 EP_NO: 10262
 Repair Type: Non-Urgent
 Crossing Status: Found
 UCIP Comments: Pipe has significant rust and exfoliation of metal showing at ends. Recommend video inspection.
 FIELD_STRUCT_DESC: 24-inch pipe through levee 15.5 feet below crown. Slide gate on waterward end and concrete headwall on landward end. (ABO No. 10262 - Cowell)
 FS Date: 4/10/2014 2:45:00 PM

LS headwall

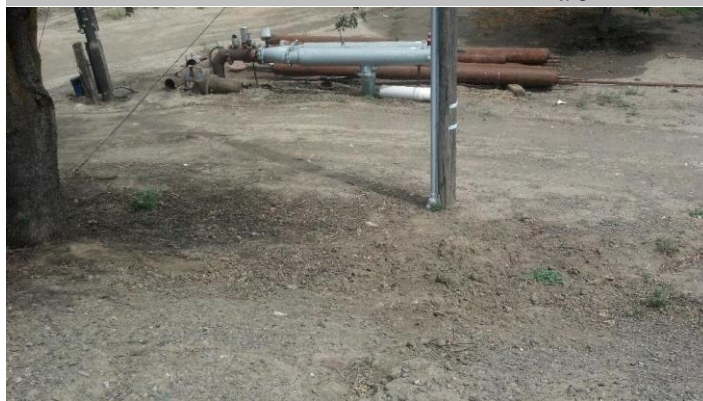
Photo 1 of 2 : UCIP_FA_2016_48013_60451.jpg

LM Start	3.22	Rating **	M	Issue No.	38
LM End	3.22	Issue Type +	En	Location *	LS
Category	Supplemental			GPS Latitude/Longitude	
				Start	End
Item	DWR UCIP Field Study			38.519731 °	38.519731 °
				-121.685681 °	-121.685681 °
DWR ID					
Comment Code					
Inspector Comment					
FS_ID:48013 DS_ID:16849 EP_NO: N/A Repair Type: Non-Urgent Crossing Status: Found UCIP Comments: Old pipe and concrete hauled to county dump. Evidence of the 14-inch pipe is no longer present at site. See new picture. FIELD_STRUCT_DESC: 10-inch steel irrigation pipe through the levee 12-feet below crown. Pipe terminates at standpipe on waterside (WS) approximately 500 feet south of levee. Mobile pumping plant located in floodway at edge of stream 740 feet south of levee. FS Date: 4/10/2014 2:42:00 PM

Filter Plant on LS toe

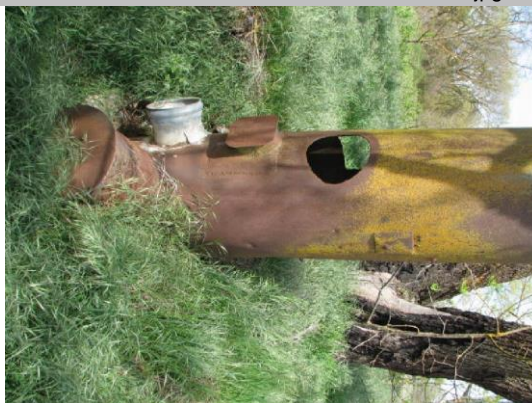
Photo 2 of 2 : UCIP_FA_2016_48013_60448.jpg

Steel Standpipe at 10-inch pipe termination 500-feet south of levee

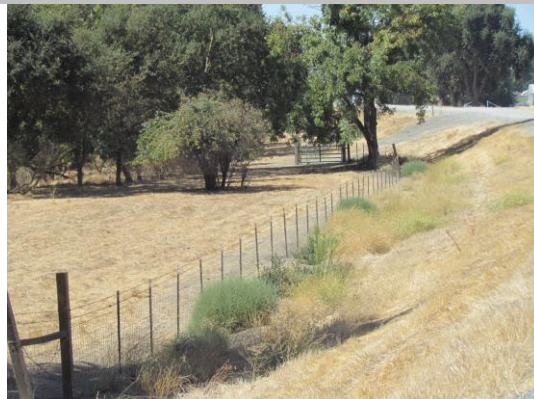
Photo 1 of 1 : FA_2016_ST0007_282_4_20161102_00026.jpg

Wire fence within the 10-foot easement waterside levee toe.

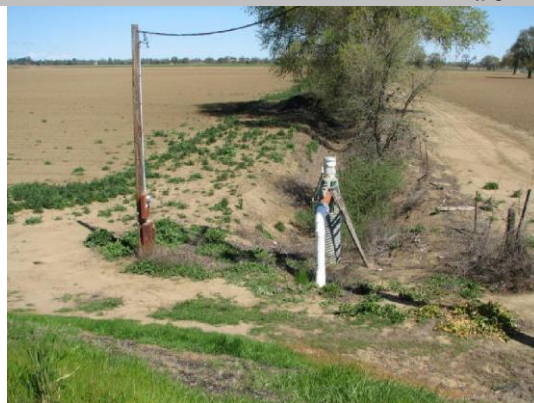
Photo 1 of 2 : UCIP_FA_2016_33367_60406.jpg

LM Start	5.56	Rating **	M	Issue No.	30
LM End	5.56	Issue Type +	En	Location *	WS
Category	Supplemental			GPS Latitude/Longitude	
				Start	End
Item	DWR UCIP Field Study			38.518250 °	38.518250 °
				-121.727685 °	-121.727685 °
DWR ID					
Comment Code					
Inspector Comment					
FS_ID:33367					
DS_ID:590					
EP_NO: 14140					
Repair Type: Non-Urgent					
Crossing Status: Found					
UCIP Comments: Air vent broken off on water side shoulder. Also, no flap gate or other positive closure device on either side of levee. No requirement in permit for applicant to install positive closure device, but it may be necessary if maintenance or upgrade is performed on pipe.					
FIELD_STRUCT_DESC: 6" PVC pipe though levee 16' FBC. 24" stand pipe with pump on land side. Pipe outfalls at creek with rip-rap.					
FS Date: 4/10/2014 2:35:30 PM

LS pump and pipe

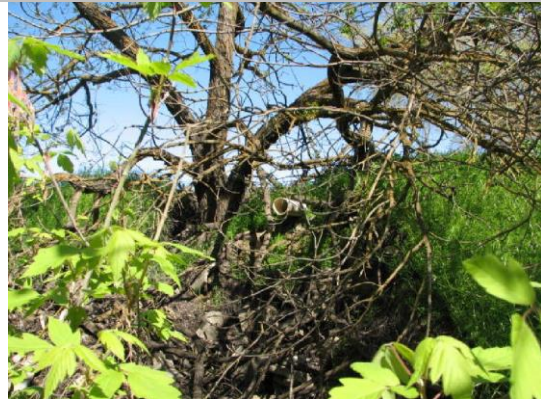
Photo 2 of 2 : UCIP_FA_2016_33367_60408.jpg

LM Start	5.56	Rating **	M	Issue No.	30 (cont)	
LM End	5.56	Issue Type +	En	Location *	WS	
Category	Supplemental			GPS Latitude/Longitude		
				Start	End	
Item	DWR UCIP Field Study			38.518250 °	38.518250 °	
				-121.727685 °	-121.727685 °	
DWR ID						
Comment Code						
Inspector Comment						
FS_ID:33367						
DS_ID:590						
EP_NO: 14140						
Repair Type: Non-Urgent						
Crossing Status: Found						
UCIP Comments: Air vent broken off on water side shoulder. Also, no flap gate or other positive closure device on either side of levee. No requirement in permit for applicant to install positive closure device, but it may be necessary if maintenance or upgrade is performed on pipe.						
FIELD_STRUCT_DESC: 6" PVC pipe though levee 16' FBC. 24" stand pipe with pump on land side. Pipe outfalls at creek with rip-rap.						
FS Date: 4/10/2014 2:35:30 PM

WS outfall at creek bank

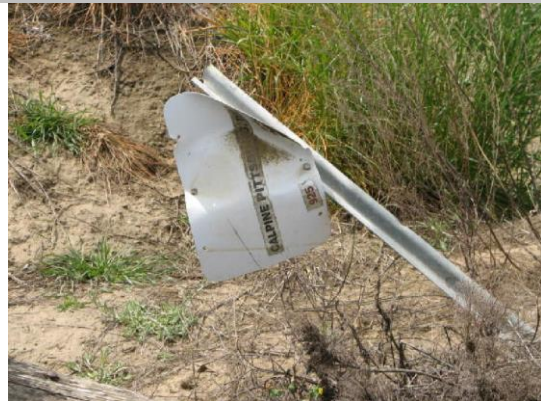
Photo 1 of 2 : UCIP_FA_2016_33347_60366.jpg

LM Start	6.48	Rating **	M	Issue No.	29
LM End	6.48	Issue Type +	En	Location *	WS
Category	Supplemental			GPS Latitude/Longitude	
				Start	End
Item	DWR UCIP Field Study			38.518120 °	38.518120 °
				-121.744570 °	-121.744570 °
DWR ID					
Comment Code					
Inspector Comment					
FS_ID:33347 DS_ID:506 EP_NO: 10820 Repair Type: Non-Urgent Crossing Status: Indicator Found UCIP Comments: Sign on LS bent over and broken. New signs need to be installed locating pipe that indicate a gas line crossing. The broken or missing signs do not indicate gasoline, only owner info. Owner is Calpine NRG Scott Vickers 707-249-9211. Supervisor will call phone number and ask for new signs to be installed. FIELD_STRUCT_DESC: 4-inch gas pipeline through the levee 2 feet below the crown. (App. No. 10820 - Dow Chemical) FS Date: 4/10/2014 2:28:50 PM

LS sign post with damaged sign.

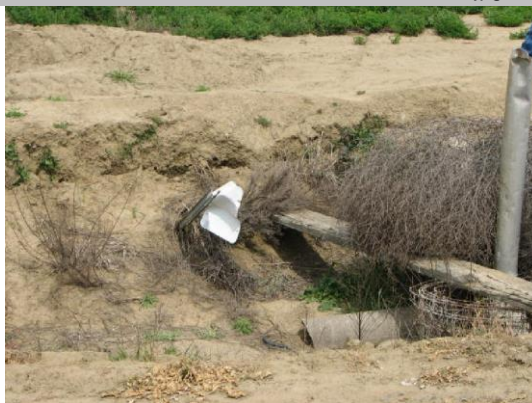
Photo 2 of 2 : UCIP_FA_2016_33347_60365.jpg

LM Start	6.48	Rating **	M	Issue No.	29 (cont)
LM End	6.48	Issue Type +	En	Location *	WS
Category	Supplemental			GPS Latitude/Longitude	
				Start	End
Item	DWR UCIP Field Study			38.518120 °	38.518120 °
				-121.744570 °	-121.744570 °
DWR ID					
Comment Code					
Inspector Comment					
FS_ID:33347					
DS_ID:506					
EP_NO: 10820					
Repair Type: Non-Urgent					
Crossing Status: Indicator Found					
UCIP Comments: Sign on LS bent over and broken. New signs need to be installed locating pipe that indicate a gas line crossing. The broken or missing signs do not indicate gasoline, only owner info. Owner is Calpine NRG Scott Vickers 707-249-9211. Supervisor will call phone number and ask for new signs to be installed.					
FIELD_STRUCT_DESC: 4-inch gas pipeline through the levee 2 feet below the crown. (App. No. 10820 - Dow Chemical)					
FS Date: 4/10/2014 2:28:50 PM

LS: sign post bent over in v ditch at toe.

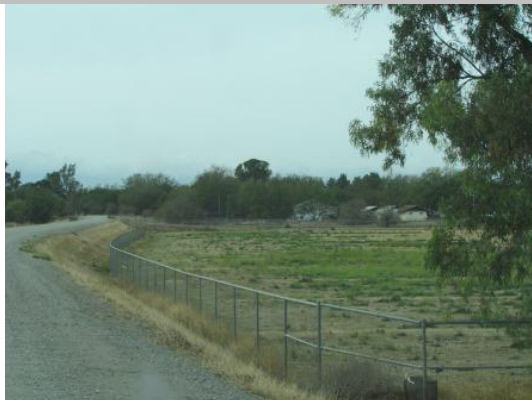
Photo 1 of 2 : FA_2016_ST0007_282_5_20160915_00002.jpg

LM Start	6.63	Rating **	M	Issue No.	5
LM End	6.71	Issue Type +	En	Location *	LS
Category	Earthen Levee			GPS Latitude/Longitude	
				Start	End
Item	Encroachments			38.517746 °	38.517647 °
				-121.747220 °	-121.748679 °
DWR ID	DWR_ST0007_01_s_2012_5				
Comment Code					
FE : Fence					
Inspector Comment					
This fence has been in the area for many years. Levee mile 6.70-6.84 lanside within10-foot of easement. No new photo ws taken.

Fence at levee mile 6.76 to 6.84 landside within 10-foot of landward toe. Not a new encroachment.

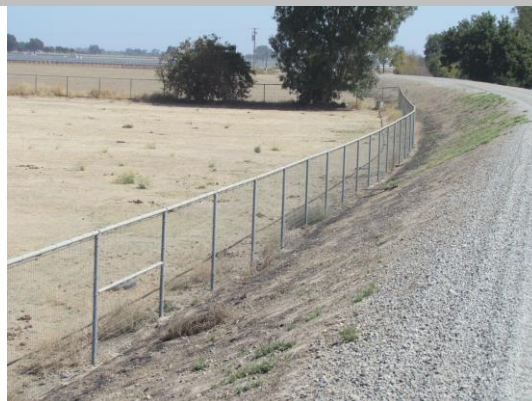
Photo 2 of 2 : FA_2016_ST0007_282_5_20161102_00027.jpg

Levee mile 6.63-6.71 landside levee toe.

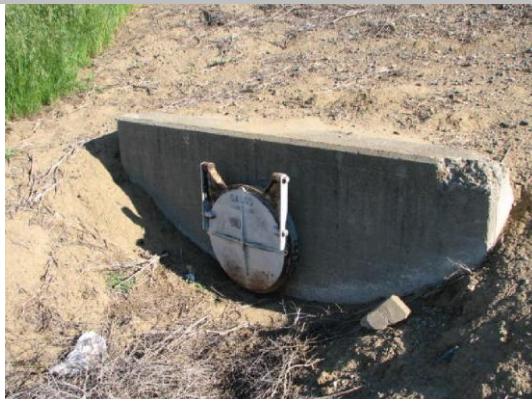
Photo 1 of 2 : UCIP_FA_2016_41353_60345.jpg

FS_ID:41353
 DS_ID:516
 EP_NO: 10260
 Repair Type: Non-Urgent
 Crossing Status: Found
 UCIP Comments: Pipe is partially obstructed with sedimentation.
 Owner of pipe may have to clean sediment
 FIELD_STRUCT_DESC: 24-inch drainpipe through the levee 12.0 feet below the crown. Flap gate on waterward end. (ABO No. 10260 S.P. Trans. Co.)
 FS Date: 4/10/2014 2:25:00 PM

WS Flap Gate and headwall.

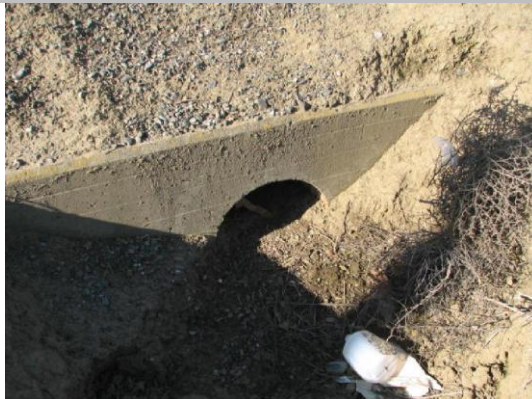
Photo 2 of 2 : UCIP_FA_2016_41353_60344.jpg

LS headwall showing pipe partially blocked with soil.

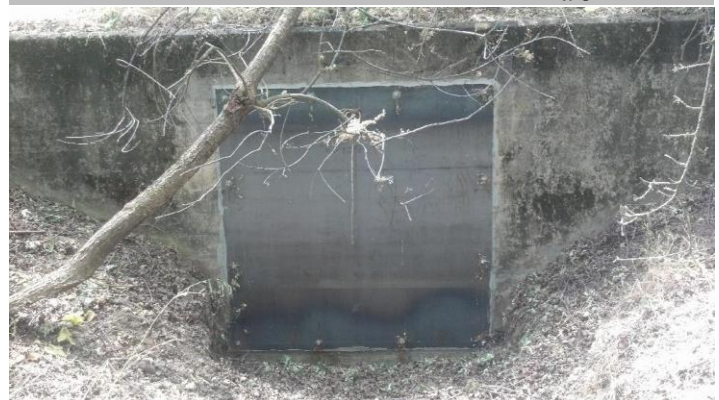
Photo 1 of 2 : UCIP_FA_2016_41129_60301.jpg

LM Start	8.69	Rating **	M	Issue No.	36
LM End	8.69	Issue Type +	En	Location *	WS
Category	Supplemental			GPS Latitude/Longitude	
				Start	End
Item	DWR UCIP Field Study			38.523999 °	38.523999 °
				-121.783037 °	-121.783037 °
DWR ID					
Comment Code					
Inspector Comment					
FS_ID:41129 DS_ID:523 EP_NO: 10247 Repair Type: Non-Urgent Crossing Status: Found UCIP Comments: *ABANDONED* FIELD_STRUCT_DESC: *ABANDONED* 48-inch drain pipe through the levee 15.0 feet below the crown. Steel plate installed over inlet off LS toe (pipe not grouted). Flap gate on waterward end. Headwall on both ends. (ABO No.10247 U.C.D.) FS Date: 4/10/2014 2:21:00 PM

Steel plate installed over pipe off LS toe.

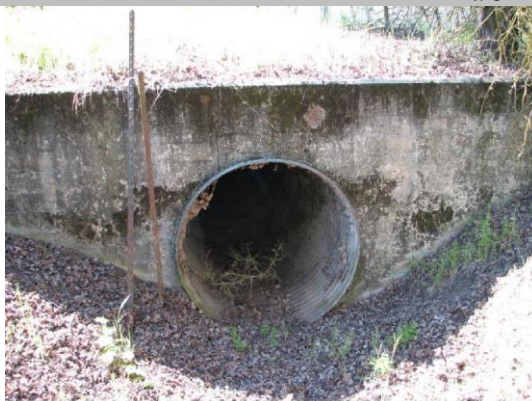
Photo 2 of 2 : UCIP_FA_2016_41129_60299.jpg

LM Start	8.69	Rating **	M	Issue No.	36 (cont)	
LM End	8.69	Issue Type +	En	Location *	WS	
Category	Supplemental			GPS Latitude/Longitude		
				Start	End	
Item	DWR UCIP Field Study			38.523999 °	38.523999 °	
				-121.783037 °	-121.783037 °	
DWR ID						
Comment Code						
Inspector Comment						
FS_ID:41129 DS_ID:523 EP_NO: 10247 Repair Type: Non-Urgent Crossing Status: Found UCIP Comments: *ABANDONED* FIELD_STRUCT_DESC: *ABANDONED* 48-inch drain pipe through the levee 15.0 feet below the crown. Steel plate installed over inlet off LS toe (pipe not grouted). Flap gate on waterward end. Headwall on both ends. (ABO No.10247 U.C.D.) FS Date: 4/10/2014 2:21:00 PM

LS headwall and pipe before steel plate was installed over pipe to abandon it.

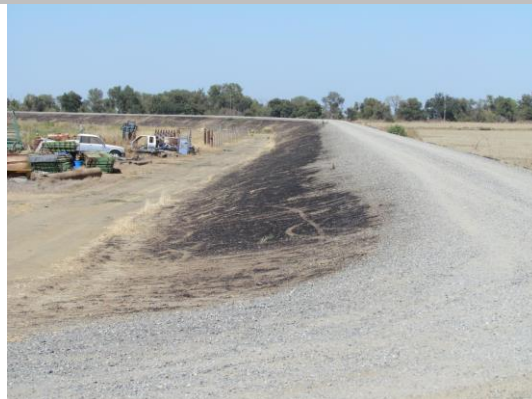
Photo 1 of 1 : FA_2016_ST0007_283_17_20161103_00021.jpg

Putah Creek looking downstream from levee mile 0.00 landside.

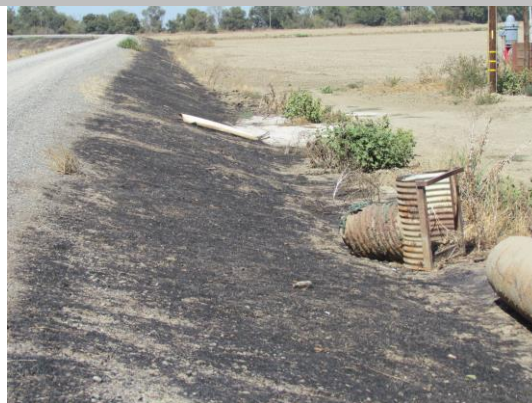
Photo 1 of 1 : FA_2016_ST0007_283_18_20161103_00022.jpg

LM Start	0.01	Rating **	M	Issue No.	18
LM End	0.01	Issue Type +	Ma	Location *	WS
Category	Earthen Levee			GPS Latitude/Longitude	
				Start	End
Item	Encroachments			38.504870 °	38.504870 °
				-121.663157 °	-121.663157 °
DWR ID	DWR_ST0007_02_f_2016_18				
Comment Code					
PI : Pipe					
Inspector Comment					
Remove the old discarded pipe from the levee section.

Putah Creek Unit 2 waterside levee mile 0.01.

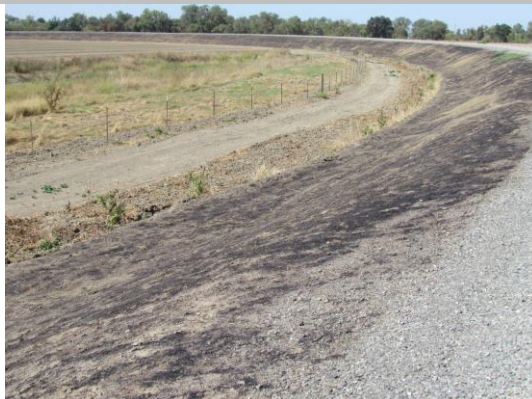
Photo 1 of 1 : FA_2016_ST0007_283_3_20161103_00023.jpg

Levee mile 0.18 looking downstream from the landside slope.

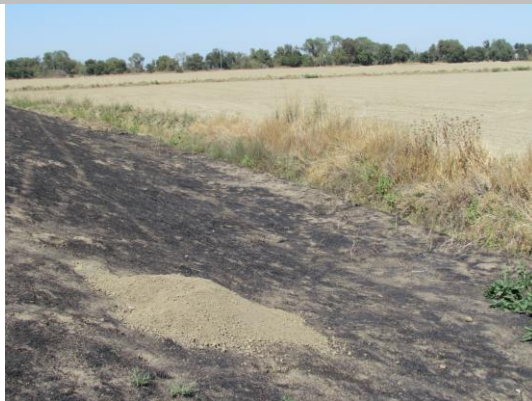
Photo 1 of 1 : FA_2016_ST0007_283_20_20161103_00024.jpg

LM Start	0.18	Rating **	U	Issue No.	20
LM End	0.29	Issue Type +	En	Location *	WS
Category	Earthen Levee			GPS Latitude/Longitude	
				Start	End
Item	Encroachments			38.507290 °	38.508803 °
				-121.662803 °	-121.663287 °
DWR ID	DWR_ST0007_02_f_2016_20				
Comment Code					
DT : Ditch					
Inspector Comment					
Agriculture ditch within the 10-foot easement.

Levee mile 0.18-0.29 waterside levee toe looking downstream.

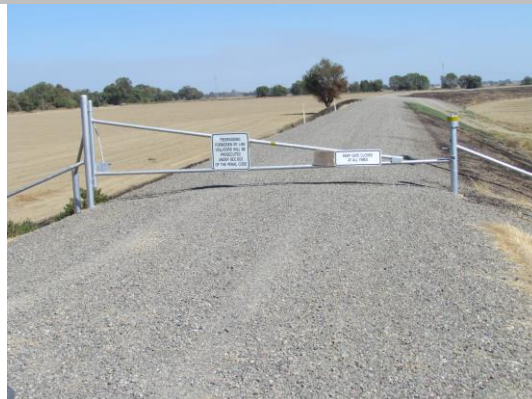
Photo 1 of 3 : FA_2016_ST0007_283_29_20161103_00025.jpg

Levee mile 0.55 crown roadway crossing.

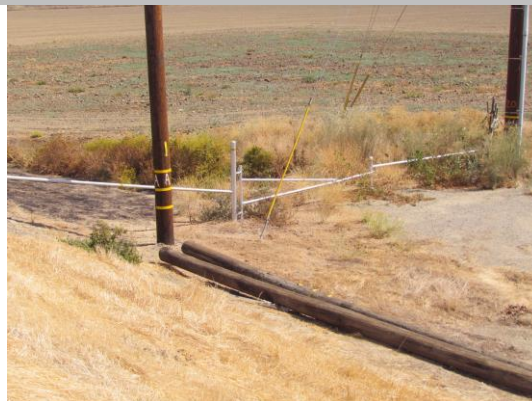
Photo 2 of 3 : FA_2016_ST0007_283_29_20161103_00027.jpg

Levee mile 0.55 landside slope and toe.

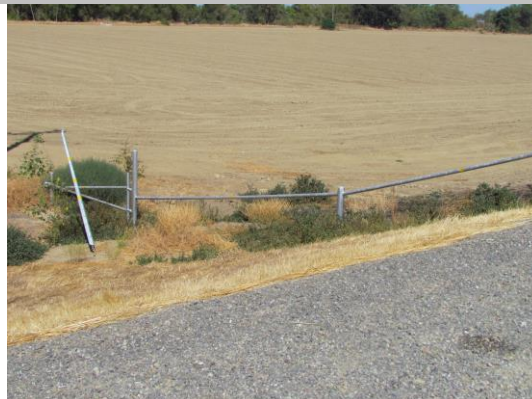
Photo 3 of 3 : FA_2016_ST0007_283_29_20161103_00028.jpg

Levee mile 0.55 waterside slope and toe.

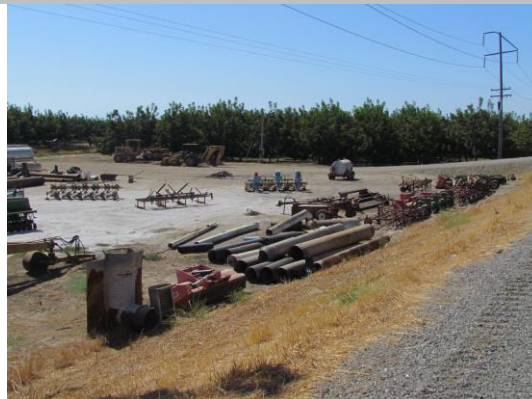
Photo 1 of 1 : FA_2016_ST0007_283_23_20161103_00029.jpg

Levee mile 1.01 landside toe looking upstream.

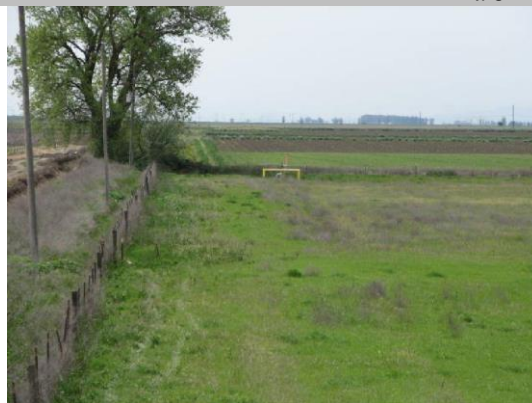
Photo 1 of 2 : UCIP_FA_2016_33400_60474.jpg

LM Start	1.60	Rating **	M	Issue No.	48	
LM End	1.60	Issue Type +	En	Location *	LS	
Category	Supplemental			GPS Latitude/Longitude		
				Start	End	
Item	DWR UCIP Field Study			38.514250 °	38.514250 °	
				-121.685980 °	-121.685980 °	
DWR ID						
Comment Code						
Inspector Comment						
FS_ID:33400 DS_ID:16623 EP_NO: 9139 Repair Type: Non-Urgent Crossing Status: Indicator Found UCIP Comments: There are no appropriate gas markers present on levee to indicate pipe location. Markers need to be installed. No danger to the levee FIELD_STRUCT_DESC: 8-inch gas line through the levee 3.0 feet below crown under channel and through Unit No. 1 levee. (Permit No. 9139 - DOW) FS Date: 4/10/2014 2:45:48 PM

Gas vent 800-feet to south

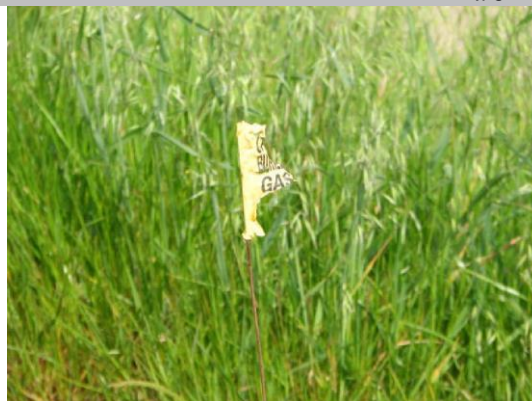
Photo 2 of 2 : UCIP_FA_2016_33400_60472.jpg

LM Start	1.60	Rating **	M	Issue No.	48 (cont)	
LM End	1.60	Issue Type +	En	Location *	LS	
Category	Supplemental			GPS Latitude/Longitude		
				Start	End	
Item	DWR UCIP Field Study			38.514250 °	38.514250 °	
				-121.685980 °	-121.685980 °	
DWR ID						
Comment Code						
Inspector Comment						
FS_ID:33400						
DS_ID:16623						
EP_NO: 9139						
Repair Type: Non-Urgent						
Crossing Status: Indicator Found						
UCIP Comments: There are no appropriate gas markers present on levee to indicate pipe location. Markers need to be installed. No danger to the levee						
FIELD_STRUCT_DESC: 8-inch gas line through the levee 3.0 feet below crown under channel and through Unit No. 1 levee. (Permit No. 9139 - DOW)						
FS Date: 4/10/2014 2:45:48 PM

small flag on WS shoulder

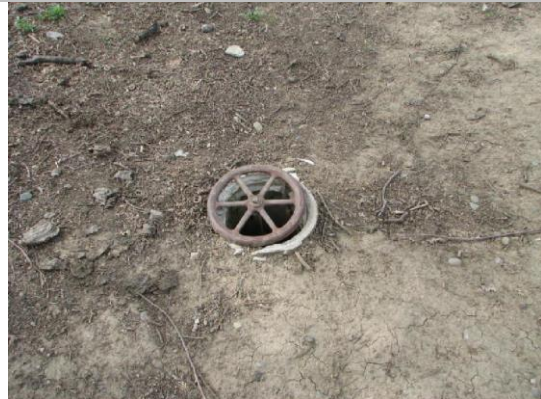
Photo 1 of 2 : UCIP_FA_2016_41072_60468.jpg

LM Start	2.09	Rating **	M	Issue No.	50
LM End	2.09	Issue Type +	En	Location *	LS
Category	Supplemental			GPS Latitude/Longitude	
				Start	End
Item	DWR UCIP Field Study			38.515440 °	38.515440 °
				-121.694920 °	-121.694920 °
DWR ID					
Comment Code					
Inspector Comment					
FS_ID:41072					
DS_ID:16624					
EP_NO: 10268					
Repair Type: Non-Urgent					
Crossing Status: Found					
UCIP Comments: It is apparent that there is an irrigation pipe sleeved through the 25-inch pipe, but size cannot be determined.					
FIELD_STRUCT_DESC: 24-inch irrigation pipe through the levee 13.0 feet below the crown. Gate valve on landward side in 10-inch concrete standpipe. 36-inch standpipe on WS toe. Headwall on LS toe. (ABO No. 10268 - DOW).					
FS Date: 4/10/2014 2:45:00 PM

gate valve on LS toe in 10-inch standpipe

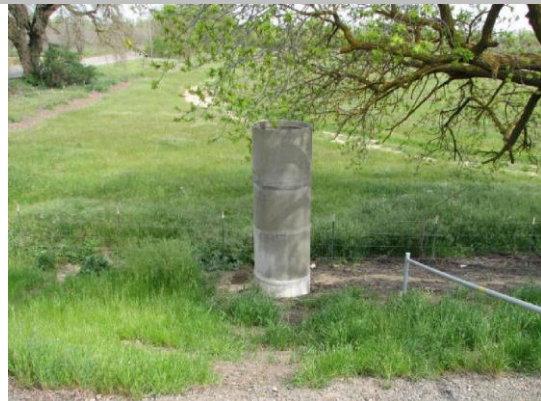
Photo 2 of 2 : UCIP_FA_2016_41072_60471.jpg

36-inch standpipe WS toe

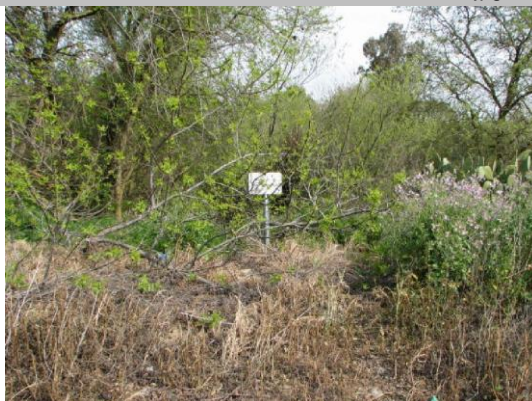
Photo 1 of 2 : UCIP_FA_2016_33377_60433.jpg

FS_ID:33377
DS_ID:16630
EP_NO: 10820
Repair Type: Non-Urgent
Crossing Status: Indicator Found
UCIP Comments: Signs for pipeline need to be updated to state Gas line. Current markers are insufficient.
FIELD_STRUCT_DESC: 4-inch natural gas pipeline across the channel and levees of Putah Creek approximately 1/2 mile downstream from Davis Road. Installed 2 feet below crown. (Permit No. 10820)
FS Date: 4/10/2014 2:39:19 PM

WS marker 320 feet north of levee at stream bank.

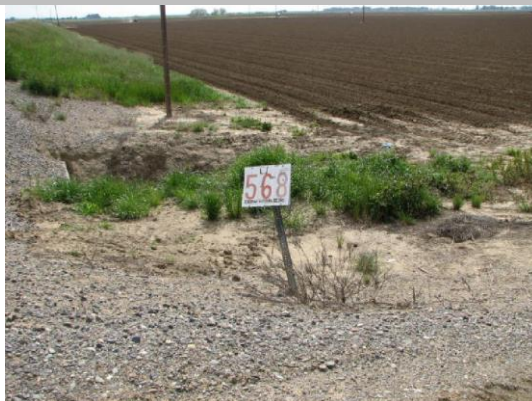
Photo 2 of 2 : UCIP_FA_2016_33377_60432.jpg

LS marker on east side of access ramp.

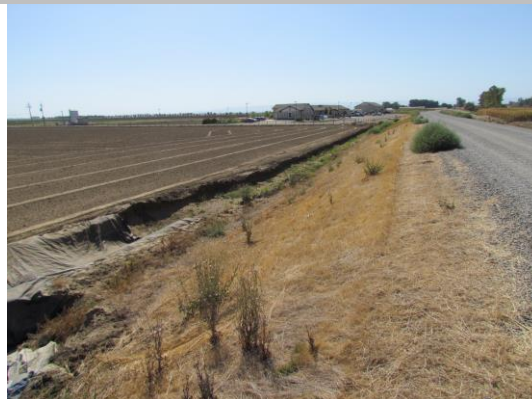
Photo 1 of 1 : FA_2016_ST0007_283_34_20161103_00031.jpg

Landside levee toe levee mile 4.97-5.00 looking upstream.

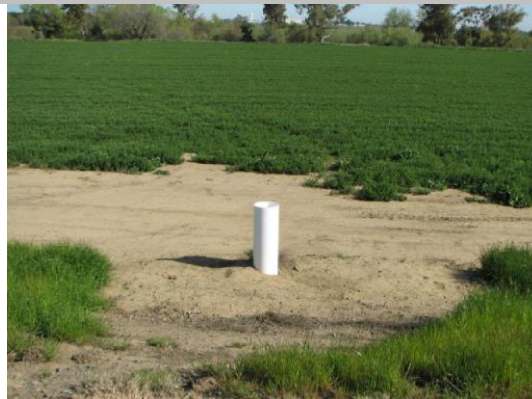
Photo 1 of 1 : UCIP_FA_2016_41074_60419.jpg

LM Start	5.07	Rating **	M	Issue No.	51
LM End	5.07	Issue Type +	En	Location *	LS
Category	Supplemental			GPS Latitude/Longitude	
				Start	End
Item	DWR UCIP Field Study			38.515332 °	38.515332 °
				-121.748533 °	-121.748533 °
DWR ID					
Comment Code					
Inspector Comment					
FS_ID:41074					
DS_ID:16632					
EP_NO: 10279					
Repair Type: Non-Urgent					
Crossing Status: Indicator Found					
UCIP Comments: Pipe and headwalls are completely buried on both sides of levee. 15-inch pipe permitted to sleeve through the 24-inch CMP. Indication that 15-inch pipe is at crossing.					
FIELD_STRUCT_DESC: 24-inch pipe through the levee 10.0 feet below the crown. Slide gate on waterward end. Concrete headwall on landward end. (ABO No. 10279 - Watkins)					
FS Date: 4/10/2014 2:37:00 PM

15-inch standpipe at location where may run through 24-inch SD.

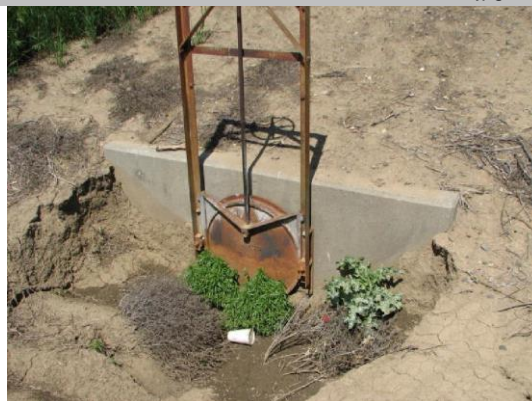
Photo 1 of 2 : UCIP_FA_2016_42959_60374.jpg

LS slide gate

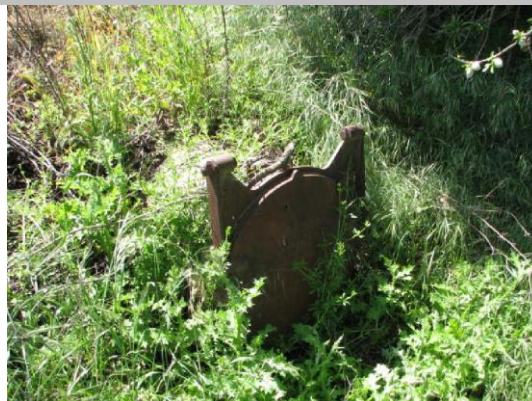
Photo 2 of 2 : UCIP_FA_2016_42959_60373.jpg

WS flap gate

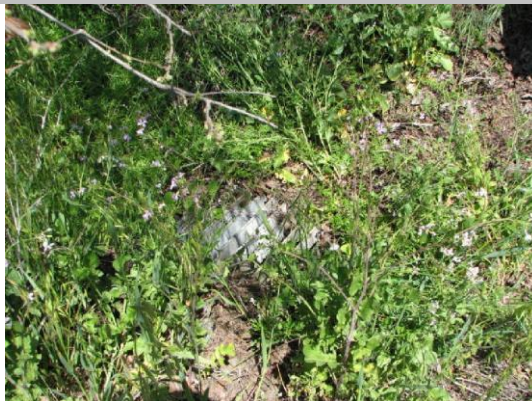
Photo 1 of 2 : UCIP_FA_2016_33348_60367.jpg

Dropinlet at LS toe.

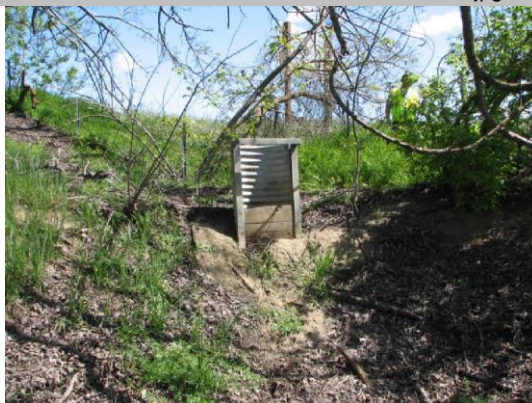
Photo 2 of 2 : UCIP_FA_2016_33348_60370.jpg

Weir inlet at pond on LS toe.

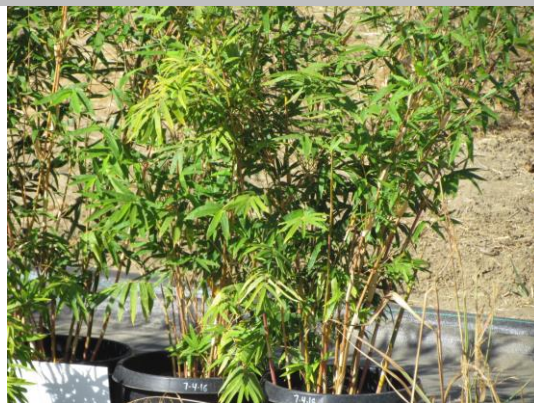
Photo 1 of 1 : FA_2016_ST0007_283_41_20161103_00032.jpg

Putah Creek levee mile 6.63-6.74 unauthorized planting of arundo plants.

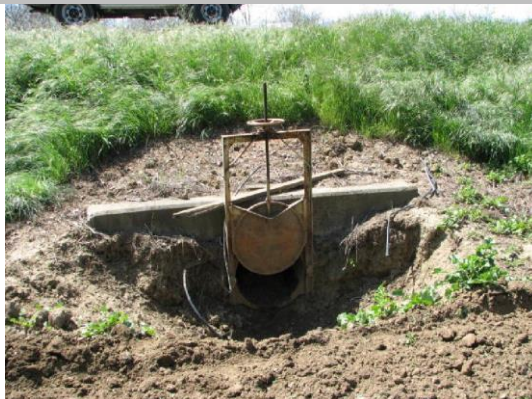
Photo 1 of 2 : UCIP_FA_2016_33346_60364.jpg

WS slide gate showing soil plug

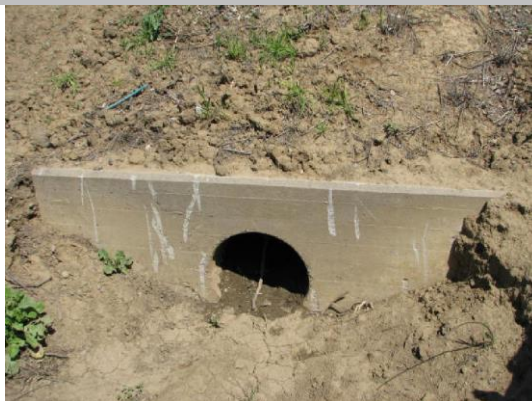
Photo 2 of 2 : UCIP_FA_2016_33346_60363.jpg

LS headwall showing soil plug
